HYDE PARK PLAN OF MANAGEMENT AND MASTERPLAN HERITAGE REVIEW STUDY								
CONDITION SURVEY								
Name of item	JOHN BAPTIST FOUNTAIN	Item number

HYDE PARK PLAN OF MANAGEMENT AND MASTERPLAN HERITAGE REVIEW STUDY		
CONDITION SURVEY		
Name of item	F.J. WALKER MEMORIAL FOUNTAIN	Item number

HYDE PARK PLAN OF MANAGEMENT AND MASTERPLAN HERITAGE REVIEW STUDY									
CONDITION SURVEY									
Name of item	Item number								
<p style="text-align: center;">CHESS BOARD</p>

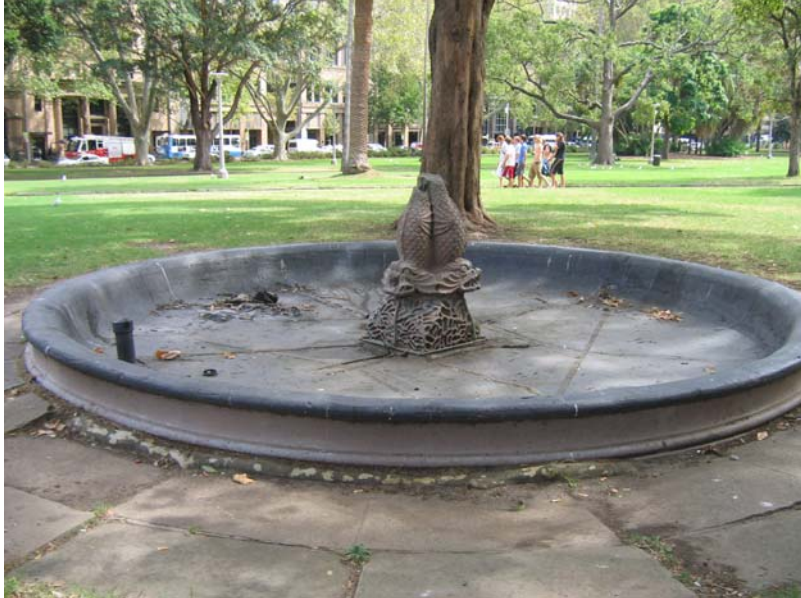
Good	In good condition	Fair	Needs monitoring	Poor	Needs attention
Good	In good condition							
Fair	Needs monitoring							
Poor	Needs attention							
Surrounds	Trees	Good						
	Sandstone path	Poor						
Concrete pond	Rim	Fair						
	Pond surface	Poor						
Sandstone fountain	"Sponge" stone base	Poor						
	Sculptured fish	Poor						
Hydraulic system	Generally	Poor						
Plaque	Bronze plaque – on pond rim	Fair

John Baptist pond is generally in poor condition. The following works required if the item is retained in the Park or moved to another location as recommended in this report for re-erection in another location that is more related to its history and the gardens established by John Baptist.

Surrounds	Trees	Needs monthly monitoring.
	Sandstone path	Relay to minimise trip hazard. Needs monthly monitoring.
Concrete pond	Rim	Tree roots to be removed, and make good. Repair damaged sections, and repaint.
	Pond surface	Repair cracks and re-grout joints, repaint with waterproof finish.
Sandstone fountain	Sponge base	Repair damaged sections and repaint.
	Sculptured fish	Repair damaged section and repaint.
Hydraulic system	Generally	Repair and re-commission.
Plaque	Bronze plaque	Clean.

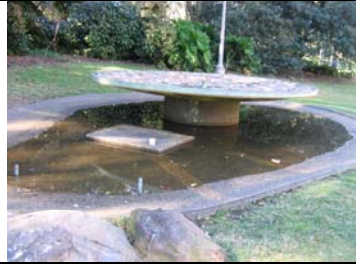
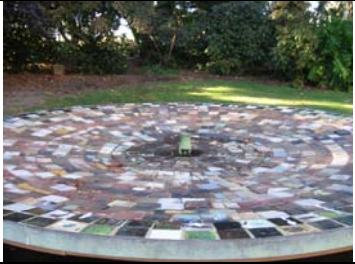
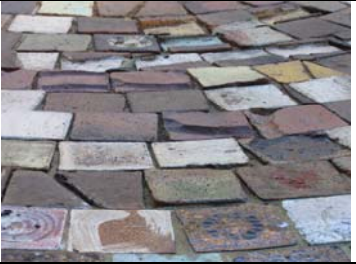
1. View of north face of fountain.		2. View of circular dish and tiles.	
3. Detailed view of tiles in terracotta, yellow, green and white.

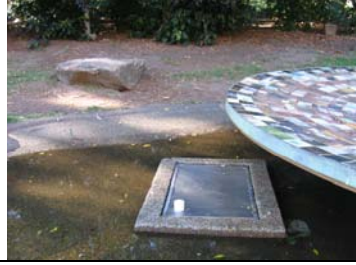
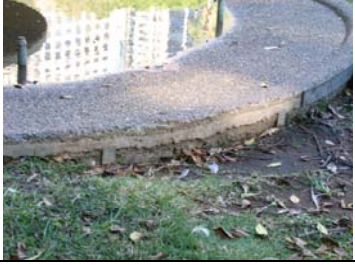
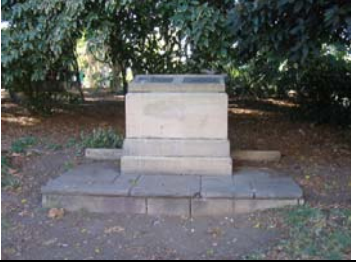
4. View of concrete and steel grate to fountain base.		5. View of missing bronze skirting at base of fountain.	
6. View of west face of plaque.

Clean bird defecation at leg of south statue.
	South east (side)		Remove cobwebs. Clean bird defecation. Replace missing mortar joints to perpends at shoulders and waists of figures, to match existing colour and consistency. Repair chipped stone to base of figures.
	Concrete foundation		No work.
Plaque	Plinth	Base	Clean dirt and grime.
		Capping Stone	Clean dirt and grime.
	Plaque	Tier 1 (bottom)	Clean bird defecation.
		Tier 2	Replace missing mortar to bed joint to match existing colour and consistency
		Tier 3	Clean dirt and grime.
	Tier 4 (top) and plaques	Clean dirt and grime.	
Stones	Clean bird defecation and remove algae from surface.

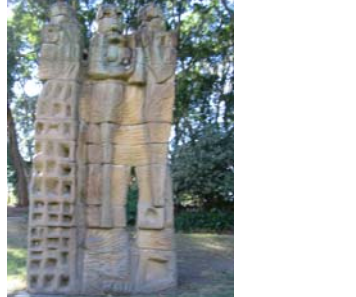
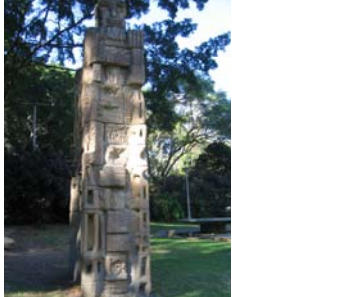
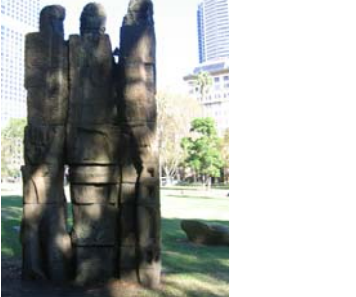
7. View south western face (front) of sculpture.		8. View of north western face (side) of sculpture.	
9. View north eastern face (back) of sculpture.

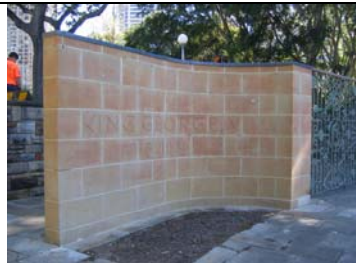
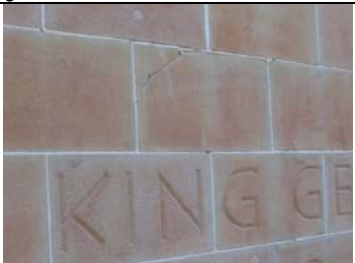
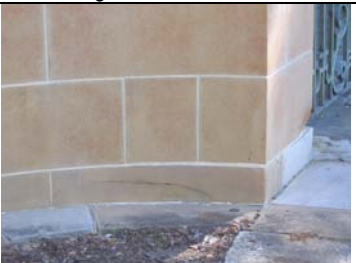
<p>CONDITION: Sandringham Gardens and Memorial Gardens are generally in good condition, i.e. the garden beds and fountain; however the pergolas and memorial gates are in poor condition and in need of urgent attention to deter future deterioration and damage.</p>			<p>CONDITION LEGEND</p>		
			Good	In good condition	Fair
			Poor	Needs attention	
Gardens	Garden beds	Good			
Fountain	Pond	Good			
	Hydraulics	Good			
Pergolas	South	Poor			
	North	Fair			
Memorial Gates	Sandstone wall – south	Poor			
	Sandstone wall –lead capping	Good			
	Memorial gates	Good			
	Sandstone wall - north	Poor			
	Sandstone wall- lead capping	Good			
W: projects/280177/o-design/site analysis/condition of sig-19.doc		Date: 12 July 2006	Final Rev-B	BMC	1 of 2
© HBO+EMTB 2006

1. View of east face of south sandstone wall at memorial gates.	2. View of cracked stone to east face of south sandstone wall at memorial gates.	3. View of cracked stone to base of east face of south sandstone wall at memorial gates.

RECOMMENDATION:		
Sandringham Gardens and Memorial Gates appear to be in good condition due to constant upgrade; however the memorial gates and supporting walls are not weathering well.		
Gardens	Garden beds	Continue current maintenance program.
Fountain	Pond	Monthly monitoring.
	Hydraulics	Monthly monitoring.
Pergolas	South	Complete restoration program and initiate a bi-annually maintenance inspections.
	North	Inspect stone piers, and trim foliage to pergola cover, renew damaged and deteriorated timber beams and rafters. Initiate a bi-annual maintenance program.
Memorial Gates	Sandstone wall – south	Investigate rising damp and surface deterioration of stone surface at low level, and renew damaged stone.
	Memorial gates	Good
	Sandstone wall - north	Investigate rising damp and surface deterioration to stone surface at base below plaque, and renew damaged stone. Remove graffiti from eastern and western face.

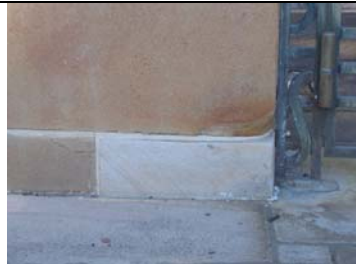
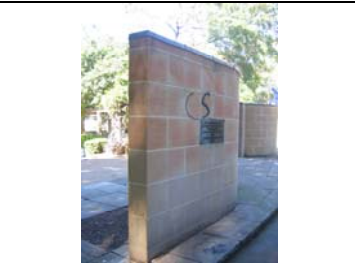
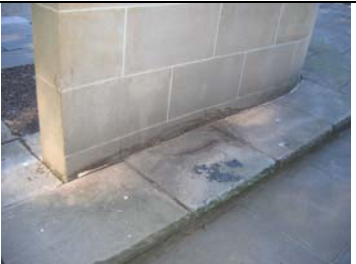
4. View of base to base of east face of south sandstone wall.	5. View of graffiti to west face of north sandstone wall.	6. View of algae to base of west face of north sandstone wall.

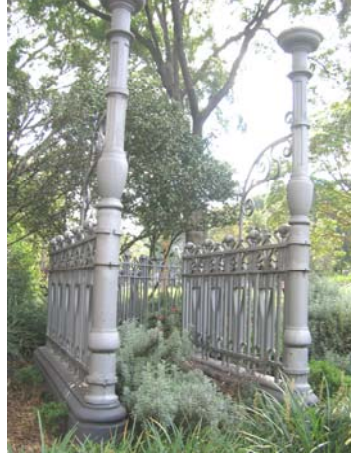
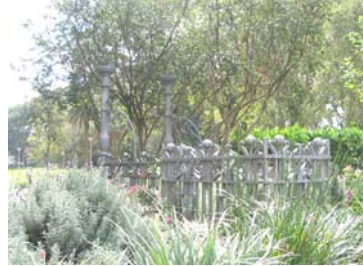
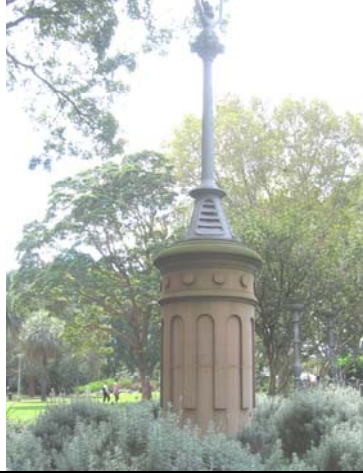
1. Western toilet entrance.	2. View of eastern toilet entrance and iron balustrade.	3. Light post / toilet vent between toilets.

Eastern toilet	Balustrade	Fair
	Entry posts	Good
Western toilet	Balustrade	Fair
	Entry posts	Good
Light Post	Base	Fair
	Post	Good
RECOMMENDATION:		
The components of the former underground conveniences are in a fair condition at above ground. A below ground assessment should be undertaken when the infill soil has been removed.		
Eastern toilet	Balustrade	Remove rust on balustrade and treat with anti rust finish.
	Entry posts	Treat with anti rust finish.
Western toilet	Balustrade	Remove rust on balustrade and treat with anti rust finish.
	Entry posts	Treat with anti rust finish.
Light Post	Base	Remove algae on top of base.
	Post	Treat with anti rust finish and check function of light fitting.
REFERENCES:		
www.cityofsydney.nsw.gov.au/waterexhibition/PublicConveniences/Women.html - accessed on 4/5/06		
http://www.pc.gov.au/inquiry/heritage/subs/subdr238.pdf - accessed 12/5/06		
Note: The Condition Survey should be read in conjunction with the Statements of Significance for this item, the Park and associated reports: SOM (Sydney Artefact Conservation, Maintenance Strategy for the Sydney Open Museum, prepared for the City of Sydney, Feb 2000).

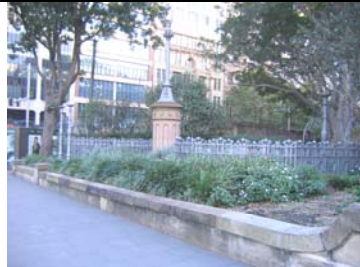
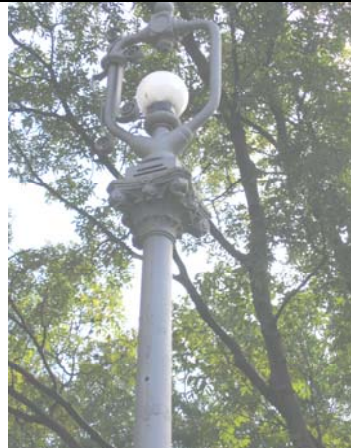
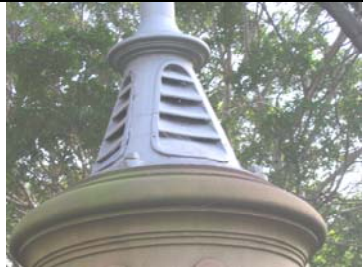
4. View of western toilet, light post and eastern toilet beyond.	5. Detailed view of light post with light fitting above.	6. Detailed view of light post and iron vent to base.

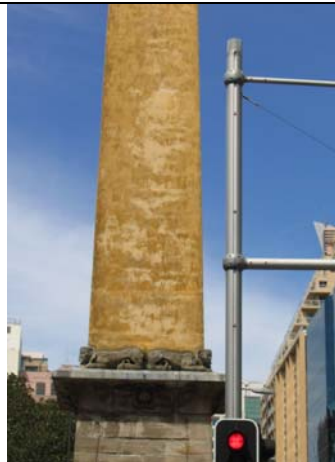
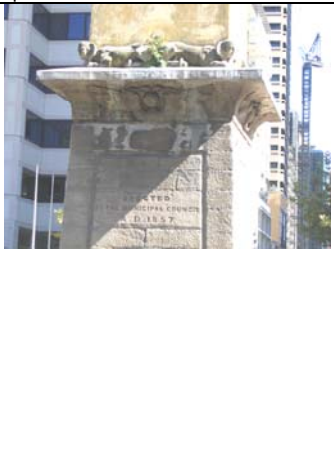
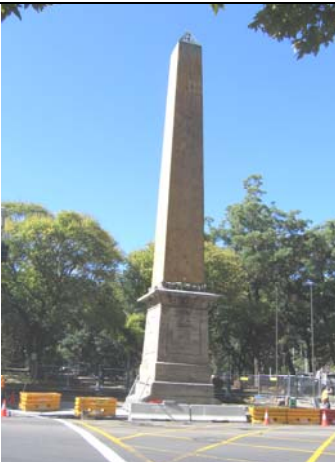
Base	Bottom tier	Fair
	Middle tier	Fair
	Top tier	Fair
	Sphinx	Fair
Shaft	Obelisk	Fair
Apex	Bronze pyramid	Fair
RECOMMENDATION: Regular maintenance should be carried out.		
Base	Bottom tier	Repair crack to centre stone on east face. Clean dirt and grime off surfaces.
	Middle tier	Repair chipped stone to bottom course of tier on west face. Repair cracks to top course of east and west faces. Clean dirt and grime off surfaces.
	Top tier	Repair cracked sandstone to east, south and west faces Clean dirt and grime off surfaces.
	Sphinx	Remove plants growing between statues Clean dirt and grime off surfaces and check surface condition. Note: consolidant was applied in 1990
Shaft	Obelisk	Remove copper stains to top part of the shaft where the apex is mounted on all four sides. Recoat lime wash.
Apex	Copper pyramid	Needs to be examined
REFERENCES: NSW Heritage Office Register, (NSWHO) SHR 01642 City of Sydney Heritage Database (CSHD), SHI No 2424612 Note: The Condition Survey should be read in conjunction with the Statements of Significance for this item, the Park and associated reports: NSWHO SHR 01642, CSHD SHI No 2424612 and SOM (Sydney Artefact Conservation, Maintenance Strategy for the Sydney Open Museum, prepared for the City of Sydney, Feb 2000).

4. View of northern face of shaft showing rendered brick face.	5. View of northern face of top tier showing plants growing between sphinx.	6. View of western face of obelisk from Bathurst Street.

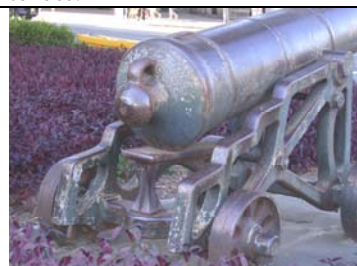
CONDITION: The Fort Macquarie Cannon is generally in fair condition, however due to its location, it is subject to graffiti. An inspection of the cannon's interior face of the barrel could not be carried out due to access limitations.		CONDITION LEGEND			
		Good	In good condition		
		Fair	Needs monitoring		
		Poor	Needs attention		
Concrete base slab	Surface	Fair			
Wheels	Rear-north	Fair			
	Rear-south	Fair			
W: projects/280177/o-design/site analysis/condition of sig-12doc © HBO+EMTB 2006		Date: 12 July 2006	Final Rev-B	BMC	1 of 2

1. View of rear section of cannon showing green paint peeling to surface.

Concrete base slab		Remove moss growth.
Wheels	Rear-north	Remove cobwebs. Remove paint and treat rust. Renew paint to achieve durability and rust resistance.
	Rear-south	Remove cobwebs. Remove paint and treat rust. Renew paint to achieve durability and rust resistance.
	Front-north	Remove cobwebs. Remove paint and treat rust. Renew paint to achieve durability and rust resistance.
	Front-south	Remove cobwebs. Remove paint and treat rust. Renew paint to achieve durability and rust resistance.
Axle	East	Remove paint and treat rust. Renew paint to achieve durability and rust resistance.
	West	Remove paint and treat rust. Renew paint to achieve durability and rust resistance.
Triangular cart	North	Remove paint and treat rust. Renew paint to achieve durability and rust resistance.
	South	Remove paint and treat rust. Renew paint to achieve durability and rust resistance.
	Pins	Remove paint and treat rust. Renew paint to achieve durability and rust resistance.

Barrel	Exterior	Remove paint and treat rust. Renew paint to achieve durability and rust resistance.
	Interior	Not inspected.

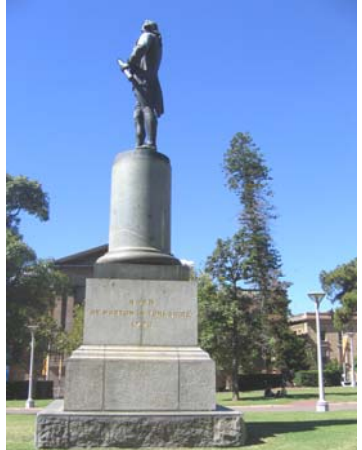
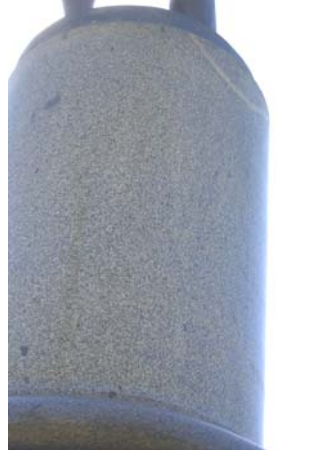
4. View of previously repaired middle tier.	5. View of statue at west face showing its surrounding grass, trees, and College Street.	6. View of previously repaired middle tier.

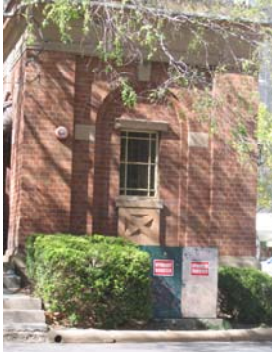
1. View of café building to rear of station.	2. View of north western façade of station building.	3. View of south eastern façade of station building.

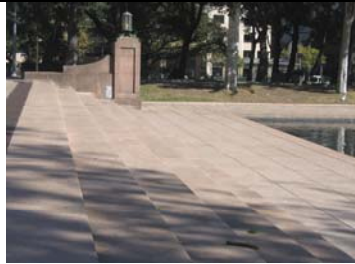
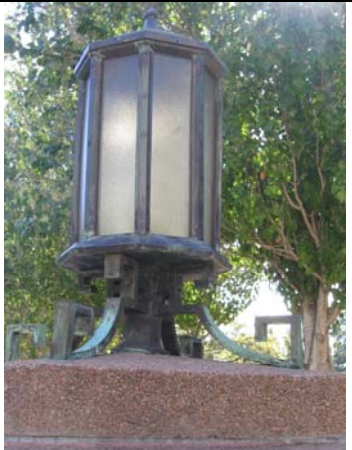
1. View of western wall with column and steps.	2. View of broken granite at inside corner of eastern column.	3. View of lantern on granite eastern column at steps.

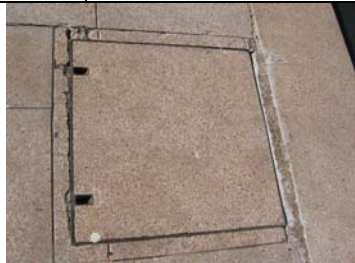
4. View of service pit at perimeter, north of pool.	5. View of missing stone face at base of inside face of eastern column.	6. View of cracked stone at perimeter at eastern side of pool.

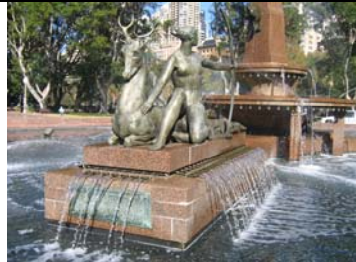
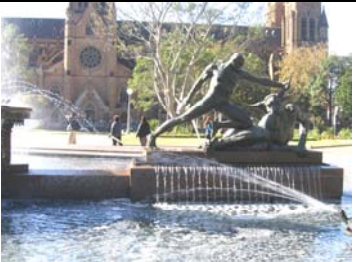
1. View of Diana on north east arm looking towards west.	2. View of Pan on north western arm looking towards south.	3. View of Thesues and Minotaur on south arm looking towards east.

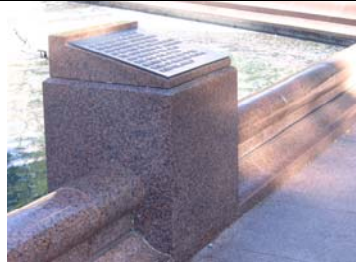
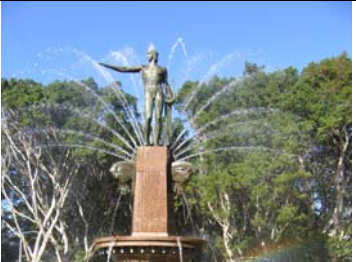
4. View of plaque on perimeter plinth at north.	5. View of turtle located on west side.	6. View of Apollo and tripod pedestal looking towards south.

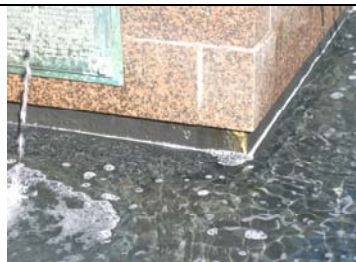
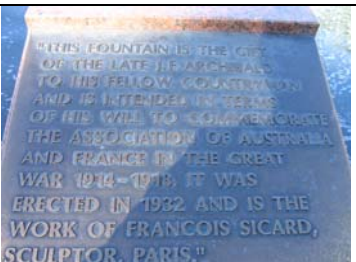
7. View of north eastern arm's base plinth showing discolouration to corner.	8. View of missing perpend and bed joints to north western arm.	9. Detailed view of writing on plaque.
