**The Council of the City of Sydney  
Sydney Park Mitigation Works, Preliminary Environment Site  
Assessment  
754-SYDEN282211-R01**

14 April 2021

# Executive Summary

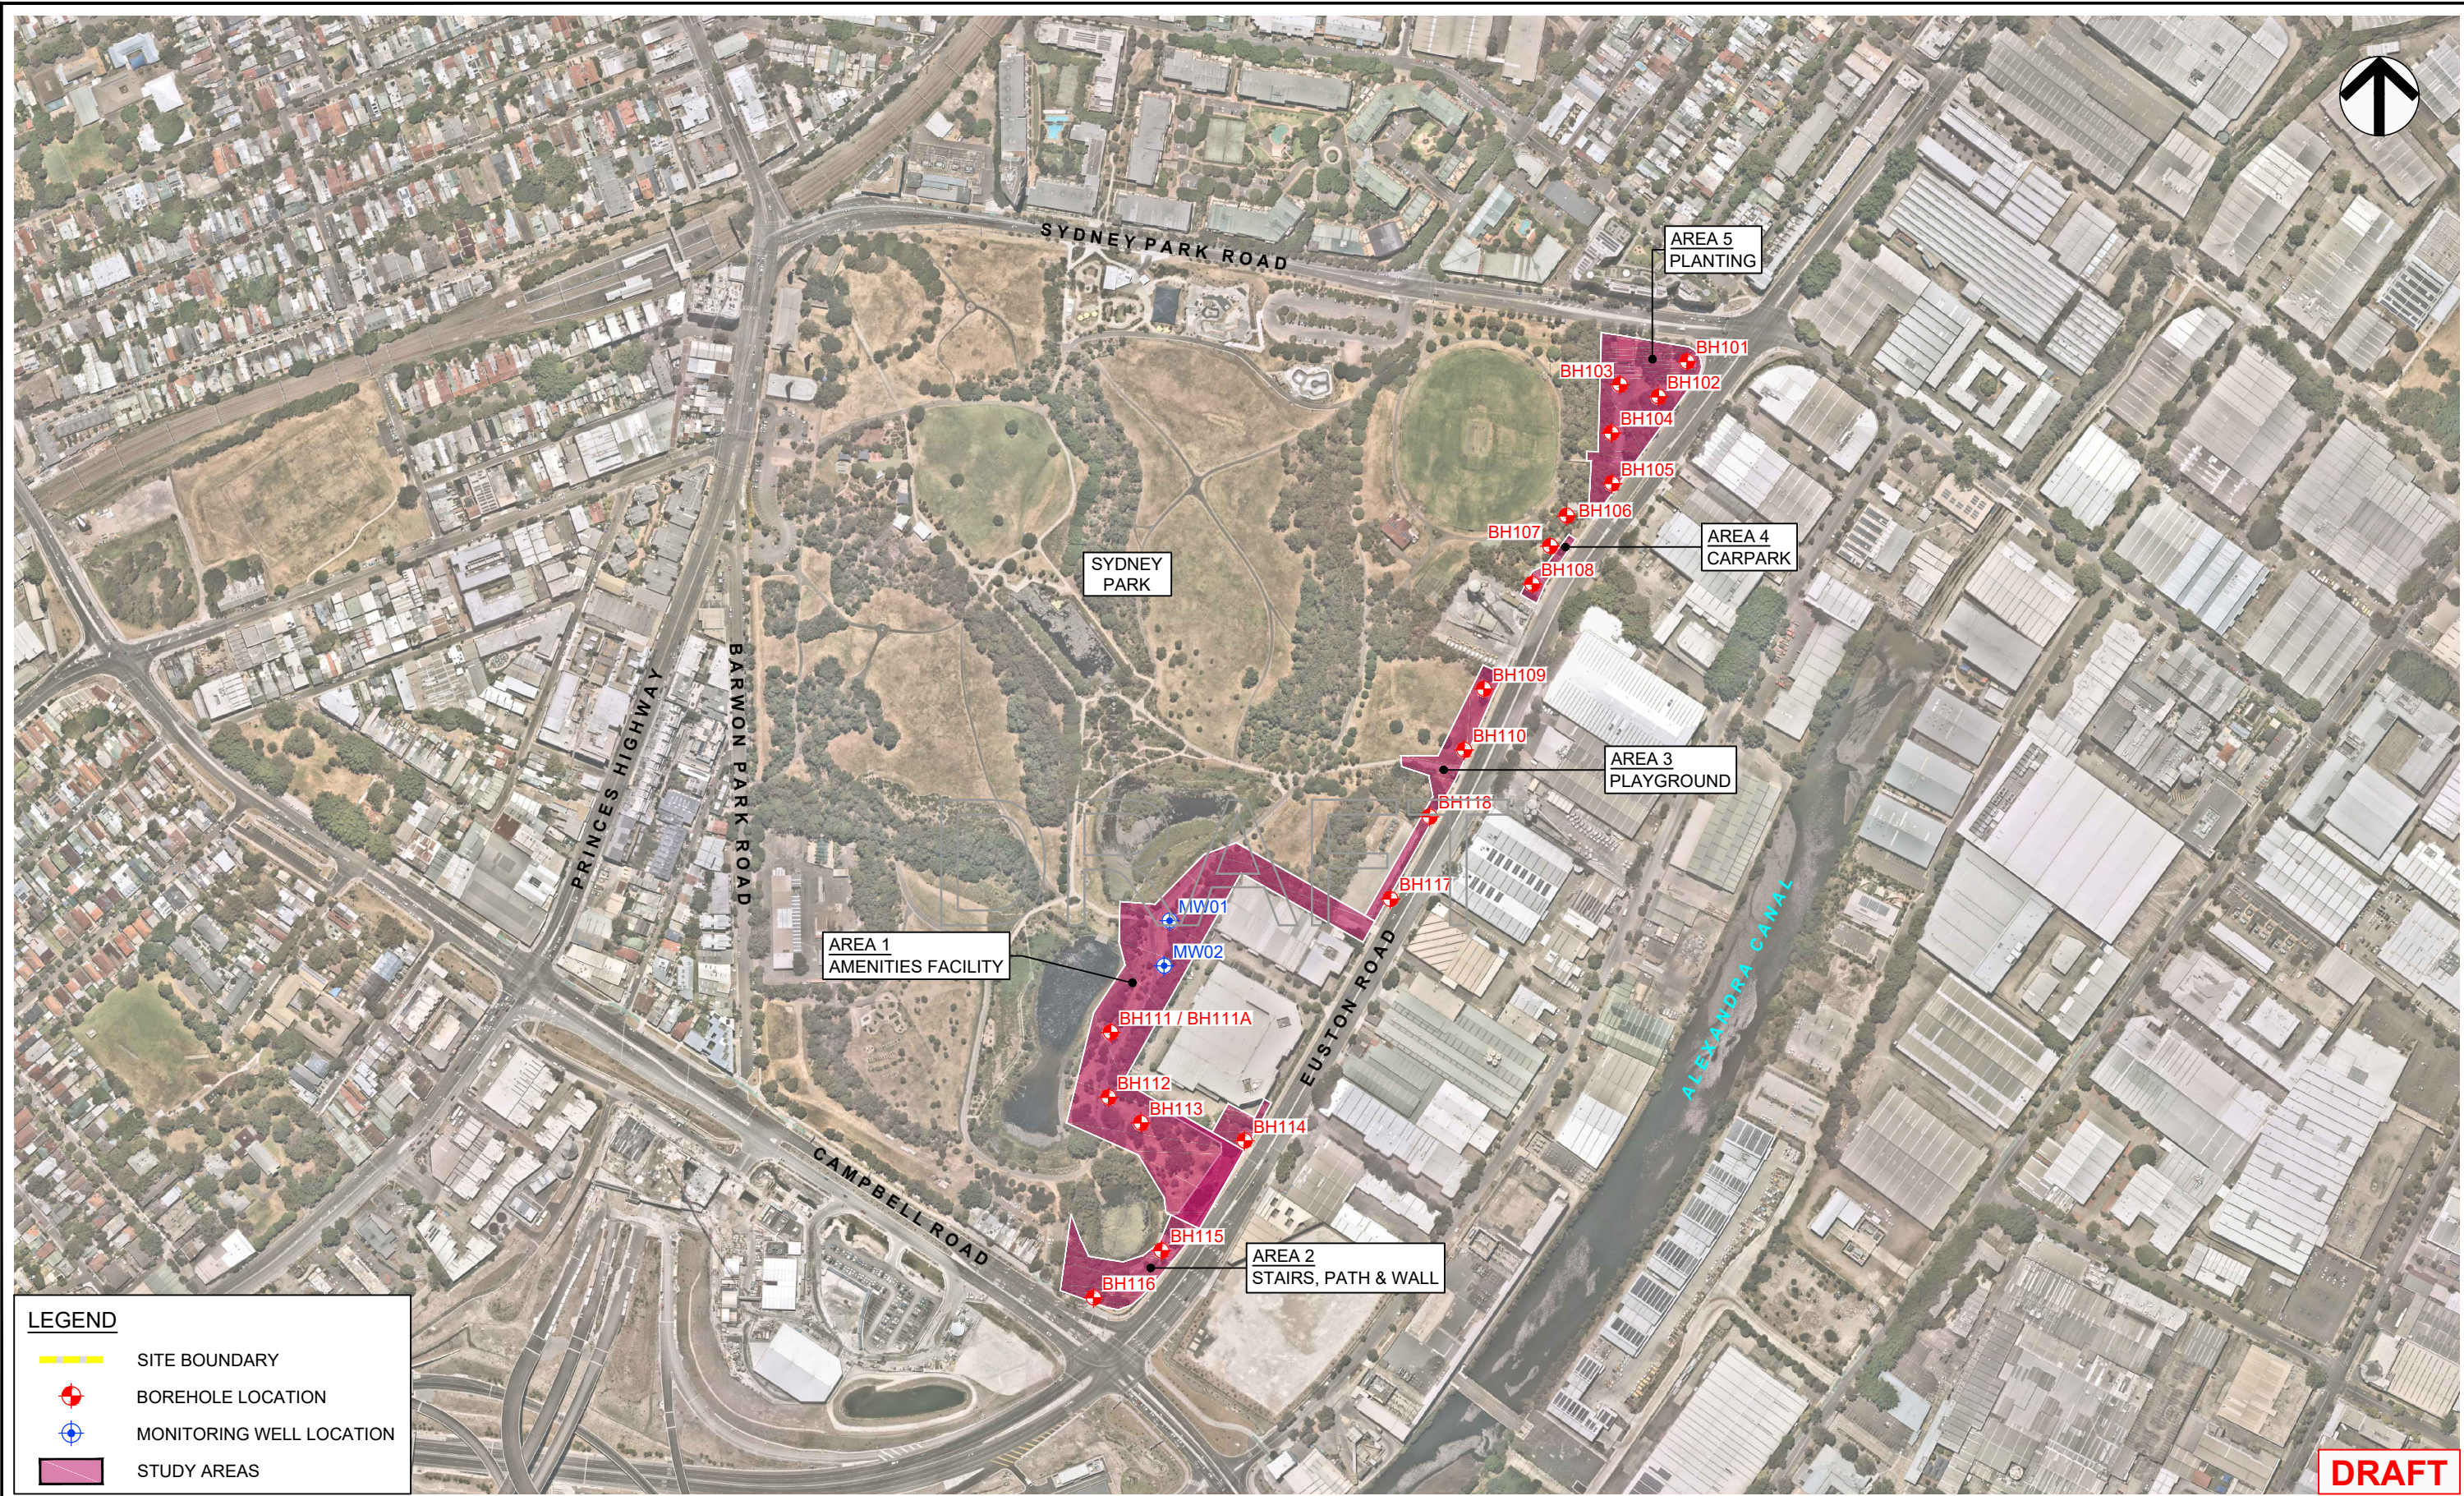
- SITE BOUNDARY
- + BOREHOLE LOCATION
- + MONITORING WELL LOCATION
- STUDY AREAS

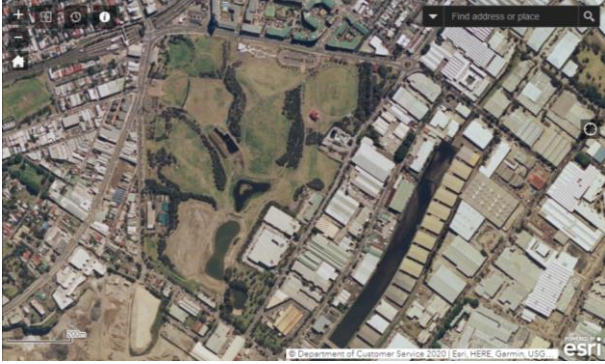
<p>This 2004 aerial photograph shows a city area with a river winding through it. A large green field is visible in the upper left, and several industrial buildings are scattered throughout the scene. The Esri logo is in the bottom right corner.</p>
1991

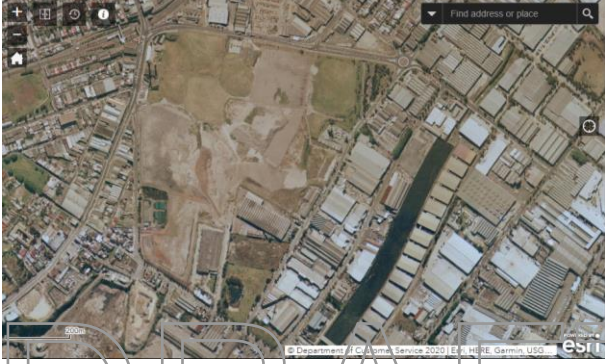
<p>This 1991 aerial photograph shows a city area with a river winding through it. A large brown field is visible in the upper left, and several industrial buildings are scattered throughout the scene. The Esri logo is in the bottom right corner.</p>
1986

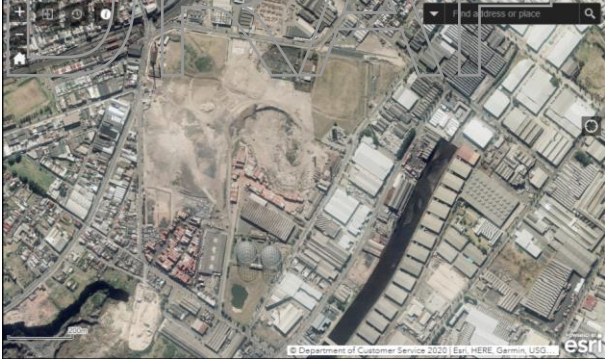
<p>This 1986 aerial photograph shows a city area with a river winding through it. A large brown field is visible in the upper left, and several industrial buildings are scattered throughout the scene. The Esri logo is in the bottom right corner.</p>
1955

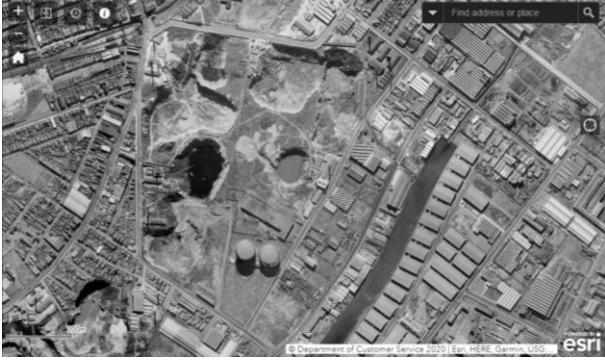
<p>This 1955 aerial photograph shows a city area with a river winding through it. A large brown field is visible in the upper left, and several industrial buildings are scattered throughout the scene. The Esri logo is in the bottom right corner.</p>
