HYDE PARK PLAN OF MANAGEMENT AND MASTERPLAN HERITAGE REVIEW STUDY								
CONDITION SURVEY								
Name of item	JOHN BAPTIST FOUNTAIN	Item number

HYDE PARK PLAN OF MANAGEMENT AND MASTERPLAN HERITAGE REVIEW STUDY		
CONDITION SURVEY		
Name of item	F.J. WALKER MEMORIAL FOUNTAIN	Item number

HYDE PARK PLAN OF MANAGEMENT AND MASTERPLAN HERITAGE REVIEW STUDY									
CONDITION SURVEY									
Name of item	Item number								
<p style="text-align: center;">CHESS BOARD</p>

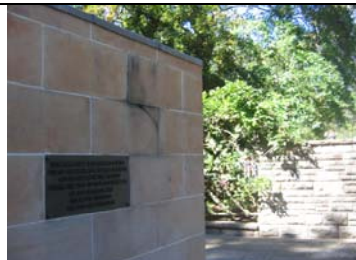
7. Detailed view of west face of north sandstone wall	8. View of northern surrounding wall at stone steps showing broken coping.	9. View of east face of northern surrounding wall.

Surrounding walls	Stone walls	Renew damaged coping stones to area of impact damage.
REFERENCES:		
City of Sydney Heritage Database (CSHD), SHI No 2426010		
Note: The Condition Survey should be read in conjunction with the Statement of Significance for this item, the Park and associated reports: CSHD (City of Sydney Heritage Database) SHI No 2426010 and SOM No.SOM030MR (Sydney Artefact Conservation, Maintenance Strategy for the Sydney Open Museum, prepared for the City of Sydney, Feb 2000).

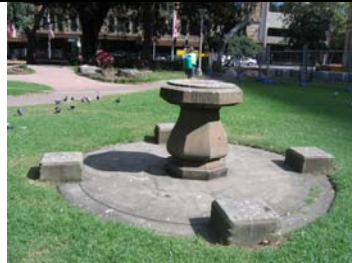
1. View of sundial from east looking west.	2. View of low sandstone pier at south.	3. View of low sandstone pier at east.

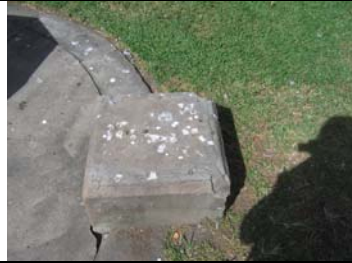
4. View of low sandstone pier at north.	5. View of low sandstone pier at west.	6. View of sundial top with missing sundial.

RECOMMENDATION:		
The sundial requires urgent attention to ensure the stone does not continue to weather.		
Concrete slab	Surface	Remove vegetation from cracks. Renew concrete topping
Low sandstone piers	North pier	Patch repair delaminated and cracked stone.
	East pier	Patch repair delaminated and cracked stone.
	South pier	Patch repair delaminated and cracked stone.
	West pier	Patch repair delaminated and cracked stone.
Sandstone monument	Shaft	Bi-annual monitoring.
	Rim	Profile and lettering have weathered.
	Horizontal surface	Repair delaminated stone.
Sundial	Bronze plaque	Re-instate missing sun dial blade.
REFERENCES:		
Sydney Open Museum Hyde Park North, Conservation Reports, 1994, No.48, prepared by International Conservation Services Pty Ltd, Sydney City Council.		
Note: The Condition Survey should be read in conjunction with the Statements of Significance for this item, the Park and associated reports: SOM No.SOM203AR (Sydney Artefact Conservation, Maintenance Strategy for the Sydney Open Museum, prepared for the City of Sydney, Feb 2000).

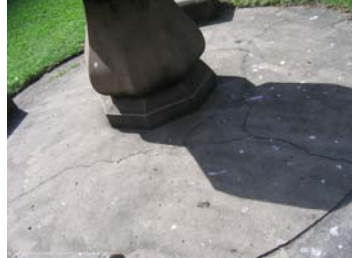
7. View of concrete slab below with cracked surface.	8. View of concrete slab below with vegetation to north east section.	9. View of algae to underside of rim to south side.

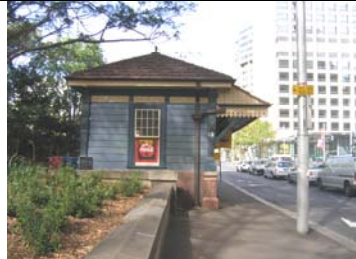
1. View of northern face of bus shelter showing relationship to park wall.	2. View of south east corner of bus shelter taken from Odd Fellows Memorial.

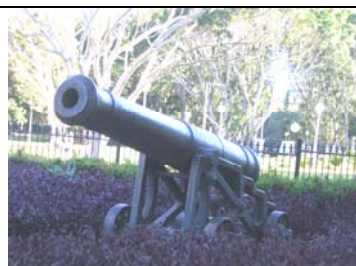
CONDITION: The Fort Macquarie Cannon is generally in fair condition, however due to its location, it is subject to graffiti. An inspection of the cannon's interior face of the barrel could not be carried out due to access limitations.		CONDITION LEGEND			
		Good	In good condition		
		Fair	Needs monitoring		
		Poor	Needs attention		
Concrete base slab	Surface	Fair			
Wheels	Rear-north	Fair			
	Rear-south	Fair			
W: projects/280177/o-design/site analysis/condition of sig-12doc © HBO+EMTB 2006		Date: 12 July 2006	Final Rev-B	BMC	1 of 2

2. View of north face of cannon looking towards south west.

Concrete base slab		Remove moss growth.
Wheels	Rear-north	Remove cobwebs. Remove paint and treat rust. Renew paint to achieve durability and rust resistance.
	Rear-south	Remove cobwebs. Remove paint and treat rust. Renew paint to achieve durability and rust resistance.
	Front-north	Remove cobwebs. Remove paint and treat rust. Renew paint to achieve durability and rust resistance.
	Front-south	Remove cobwebs. Remove paint and treat rust. Renew paint to achieve durability and rust resistance.
Axle	East	Remove paint and treat rust. Renew paint to achieve durability and rust resistance.
	West	Remove paint and treat rust. Renew paint to achieve durability and rust resistance.
Triangular cart	North	Remove paint and treat rust. Renew paint to achieve durability and rust resistance.
	South	Remove paint and treat rust. Renew paint to achieve durability and rust resistance.
	Pins	Remove paint and treat rust. Renew paint to achieve durability and rust resistance.

Barrel	Exterior	Remove paint and treat rust. Renew paint to achieve durability and rust resistance.
	Interior	Not inspected.

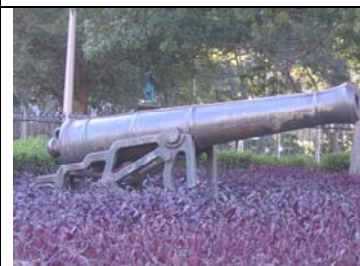
3. View of south face of cannon looking towards north.

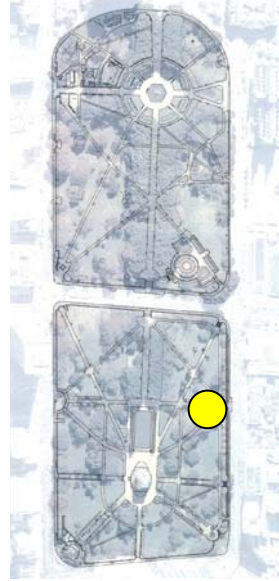
<h2>C-11</h2>	
			Location Plan

CONDITION: Survey undertaken on 12/04/06. Frazer Memorial Fountain is generally in a poor condition. Further deteriorations have occurred since conservation works in 1990. The drinking fountain is not operative. The following itemises the condition of each component of the monument.			CONDITION LEGEND	
			Good	In good condition
			Fair	Needs monitoring
			Poor	Needs attention
Base	Sandstone steps	Fair		
Buttress	Stepped base	Poor		
	Columns	Fair		
	Carved decoration	Poor		
Buttresses	Base	Fair – peeling paint over/render.		
Arches	Stone piers	Poor		
	Columns	Fair – exfoliation to details items.		
	Arches – exterior	Fair – exfoliation to detail items.		
W: projects/280177/o-design/site analysis/condition of sig-11.doc © HBO+EMTB 2006			Date: 12 July 2006	Final Rev-B
			BMC	1 of 2

Arches - Interior	Poor – powdery stain surfaces.
Entablature	Cornice	Fair – exfoliation to undersides.
	parapet	Fair
Roof	Roof	Fair
	Cupola	Fair
Fountain	Bowl and tap	Poor
	Pedestal	Fair
RECOMMENDATION:		
Frazer memorial fountain is in a poor condition and needs repair and general cleaning of the structure. The following itemises the scope of work.		
Steps	Sandstone steps	Clean dirt and grime off surfaces.
	Landing	Clean dirt and grime off surfaces.
Buttress	Base	Strip back peeling paint and recoat.
Arches	Sandstone arches	Remove white colour joints to stone and repoint in colour match stone. Remove wasp nest underside of south arch.
	Interior	Clean dirt and grime off surfaces. Install matching mortar joints to vault joints.
	Columns	Repair chipped sandstone to south east column's capital. Repair chipped sandstone to shaft of south east column. Repair chipped sandstone to south east column's capital. Repair broken finial to capital on south east column.

Piers	Repair render and paint to all piers. Remove graffiti from south pier.
Buttress	Base	Repair render and re paint all piers. Remove graffiti from south west base.
Entablature	Cornice	Reinstate broken sandstone decoration to west face. Clean dirt and grime off surfaces.
	Parapet	Clean dirt and grime off surfaces.
Roof	Roof	Clean dirt and grime off surfaces.
	Cupola	Clean dirt and grime off surfaces.
Fountain	Bowl and tap	Investigate operation of fountain including public health implications.
	Pedestal	Clean dirt and grime off surfaces.
REFERENCES:		
NSW Heritage Office Inventory, (NSWHO) database number 2451072 City of Sydney Heritage Database (CSHD), SHI No 2424615		
Note: The Condition Survey should be read in conjunction with the Statement of Significance for this item, the Park and associated reports: NSWHO database number 2451072, CSHD SHI No 2424615 and SOM No.SOM005FN (Sydney Artefact Conservation, Maintenance Strategy for the Sydney Open Museum , prepared for the City of Sydney, Feb 2000).

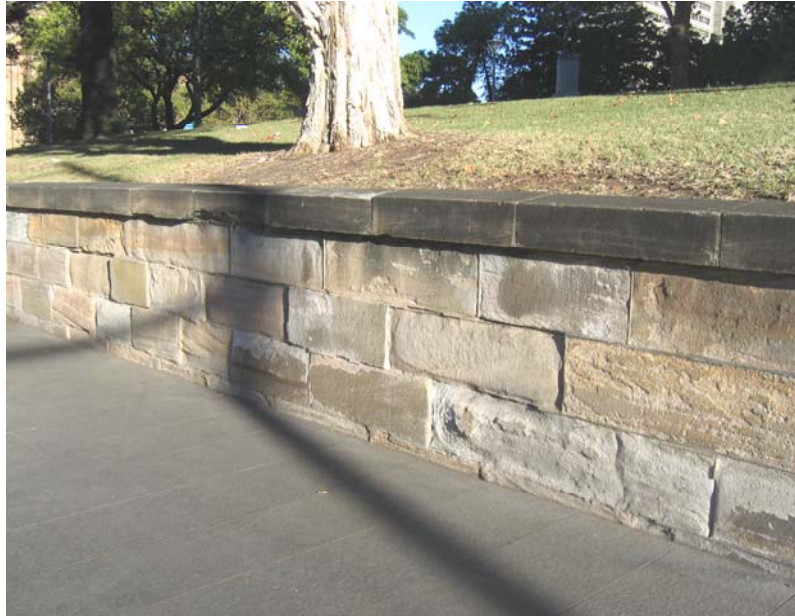
C-05b
		Location Plan

Name of item		PERIMETER WALLS AND STEPS – HYDE PARK SOUTH	Item number C-05b
ITEM NO	CONDITION	RECOMMENDATION	
01	Missing mortar joints to perpend in middle course.	Fix mortar to missing joints to match existing colour, mix and joint profile.	
02	Severe salt damage	Loss of thickness of some stones will affect stability of wall eventually. Reconstruction will be required with membrane, subsoil drain and DPC to prevent future salt attack. Salvaged stone blocks and copings may be used after desalination.	
03	Missing mortar joints to perpend in coping stone.	Fix mortar to missing joints to match existing colour, mix and joint profile.	
04	Column - North face badly exfoliated, coping stone cracked and missing mortar to bed joints	Exfoliation of stone – treat as item 02 Repair coping stone, fix missing mortar to missing joints to match existing colour, mix and joint profile.	
05	Top course badly exfoliated	Loss of thickness of some stones will affect stability of wall eventually. Reconstruction will be required with membrane, subsoil drain and DPC to prevent future salt attack. Salvaged stone blocks and copings may be used after desalination.

06	Coping stone cracked	Replace cracked stone.	
07	Middle course badly exfoliated	Loss of thickness of some stones will affect stability of wall eventually. Reconstruction will be required with membrane, subsoil drain and DPC to prevent future salt attack. Salvaged stone blocks and copings may be used after desalination.	
08	Section of wall badly exfoliated	Loss of thickness of some stones will affect stability of wall eventually. Reconstruction will be required with membrane, subsoil drain and DPC to prevent future salt attack. Salvaged stone blocks and copings may be used after desalination.	
09	Stone on top course badly exfoliated	Loss of thickness of some stones will affect stability of wall eventually. Reconstruction will be required with membrane, subsoil drain and DPC to prevent future salt attack. Salvaged stone blocks and copings may be used after desalination.	
10	Stone in bottom course badly exfoliated	Loss of thickness of some stones will affect stability of wall eventually. Reconstruction will be required with membrane, subsoil drain and DPC to prevent future salt attack. Salvaged stone blocks and copings may be used after desalination.

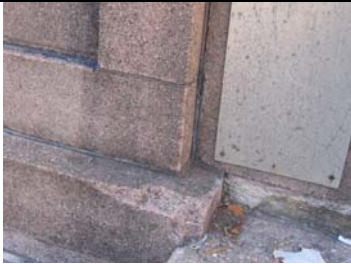
1. View of western wall with column and steps.	2. View of broken granite at inside corner of eastern column.	3. View of lantern on granite eastern column at steps.

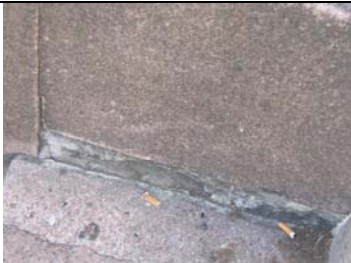
4. View of service pit at perimeter, north of pool.	5. View of missing stone face at base of inside face of eastern column.	6. View of cracked stone at perimeter at eastern side of pool.

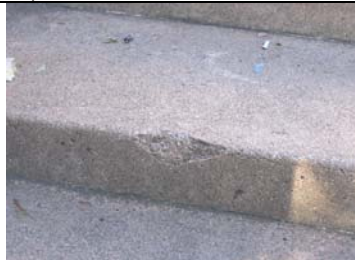
7. View of broken section of stone steps to north.	8. View of gap between perimeter paving and surrounding paving.	9. View of missing mastic joints at corner of perimeter paving.

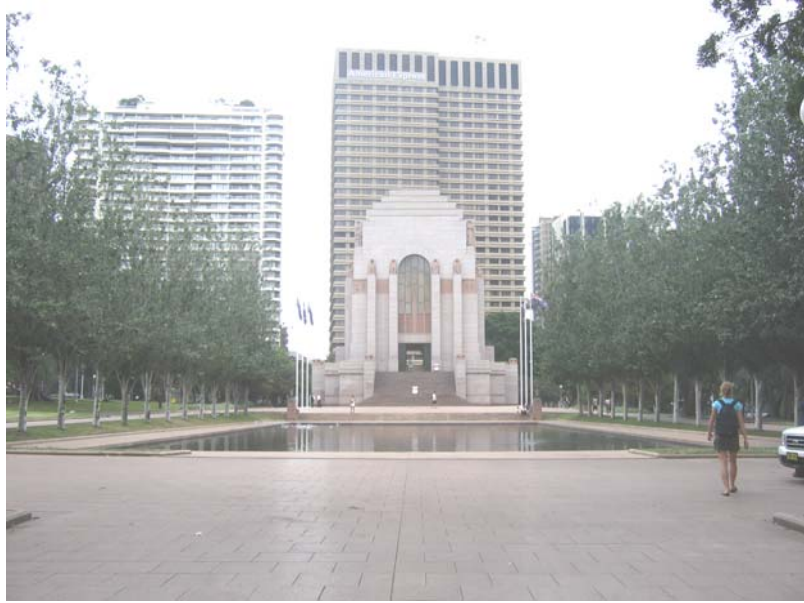
<p>C-03</p> <p>Location Plan</p>

<p>Item Location</p>						
<p>Source: Photograph taken on the 06/02/06 by Ameera Mahmood of HBO+EMTB Heritage Pty Ltd.</p>								
<p>LOCATION: The Anzac Memorial is located within Hyde Park South, at the southern end of the central avenue. The building's setting to the north is dominated by the Pool of Remembrance and a line of poplar trees to either side, and surrounded to the east, south and west by hard paved surfaces.</p>								
<p>OWNERSHIP: Anzac Memorial Trustees</p>		<p>MANAGEMENT: Anzac Memorial Trustees</p>						
<p>DESCRIPTION The Anzac Memorial is an excellent example of the Art Deco style. The structure is composed of three primary elements; a podium base surmounted with a structure with engaged piers and a ziggurat roof.</p> <p>The podium is central stairs to the north and south, on the axis of the central avenue. The stairs are clad in red granite constructed in a semi circular arrangement.</p> <p>The structure resting on the podium is orientated to follow the four compass points and rises in a square plan with engaged piers with scenes of war depicted along friezes and between the piers.</p>								
<p>CONDITION: (Exterior inspected from ground level on the 12 April 2006) The monument is generally in good condition but requires maintenance.</p>		<p>CONDITION LEGEND</p>

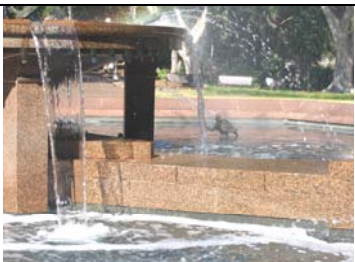
7. View of north eastern arm's base plinth showing discolouration to corner.	8. View of missing perpend and bed joints to north western arm.	9. Detailed view of writing on plaque.

Remove bird defecation.
	Base plinth	Remove algae growth to south face. Replace missing bed joints to match colour and consistency of existing mortar.
	Top plinth	No work required.
	Spouts	Repair corroded copper.
North west arm	Pan	Remove bird defecation to head.
	Goat	No work required.
	Sheep	Remove cobwebs.
	Base plinth	Replace missing joints to beds and perpend. Repair chipped sections to stone.
	Top plinth	No work required.
	Spouts	Repair corroded copper.
REFERENCES:		
City of Sydney Heritage Database (CSHD), SHI No 2424610		
Note: This Condition Survey should be read in conjunction with the Statement of Significance for the item, the Park and associated reports: CSHD and SOM No. SOM005FN (Sydney Artefact Conservation, Maintenance Strategy for the Sydney Open Museum, prepared for the City of Sydney, Feb 2000).
