**Sydney Park, St Peters - Tree Assessment Schedule**

**Tree Impact and Protection Plan Legend**

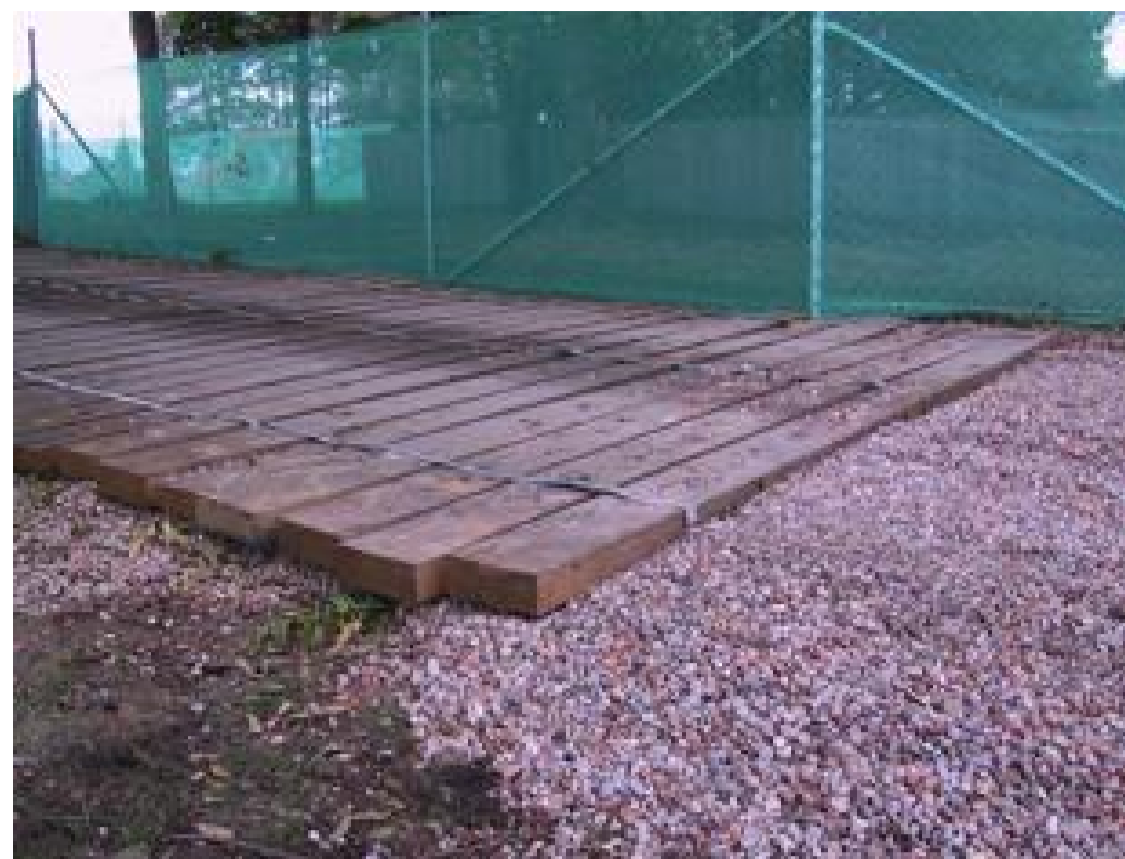
Example image of acceptable ground protection rumble boards

If it is proposed to create any access route, or similar, within the TPA of a retained tree, the Contractor shall install rumble boards over the TPA ground surface. No excavation shall be allowed. Contractor shall first place a suitable permeable geotextile to the extent required and then a 100mm thick layer of wood chip mulch or coarse no-fines gravel over the extent to be covered. Then place hardwood boards (minimum 3600 x 200 x 75mm) on their flat edge, side by side, with a 30 - 50mm gap to form a rumble strip. These boards are to be held together with three galvanised metal bracing straps nailed to each board. The two outer straps are to be approximately 200mm in from the ends of the boards. The third strap is to be along the centre line of the boards.

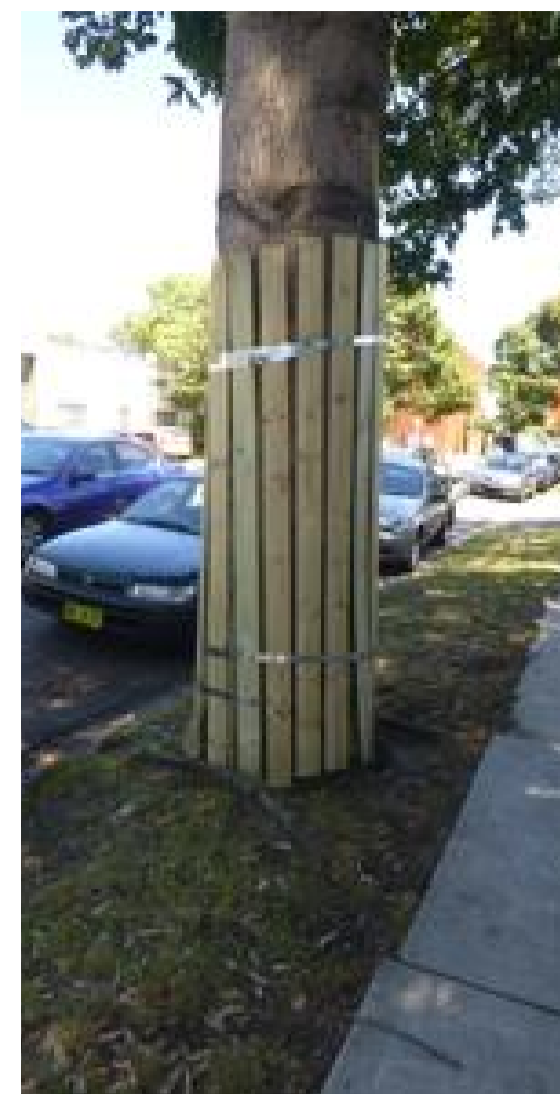
Example image of acceptable tree tree protection battens

A trunk barrier is to be erected around the circumference of the tree trunk and root buttress where shown. This barrier will consist of two to three 'rings' of 50mm diameter socked ag-line wrapped around tree trunk or branch and the ends cable tied to secure in place. A layer of battens is to be placed over and tight to the ag-lines. The battens are to have a maximum spacing of 50mm. The height of the battens is to be 2 metres or to the height of the first branches. Lower large branches may require the same protection if likely to be damaged by passing vehicles or equipment. Secure battens in place with galvanised steel bracing straps. Do not nail into or otherwise injure the trunk or bark. Battens may be made from any suitable waste timber of similar sizes and depths. All sharp or protruding edges are to be properly covered with tape or similar padding.

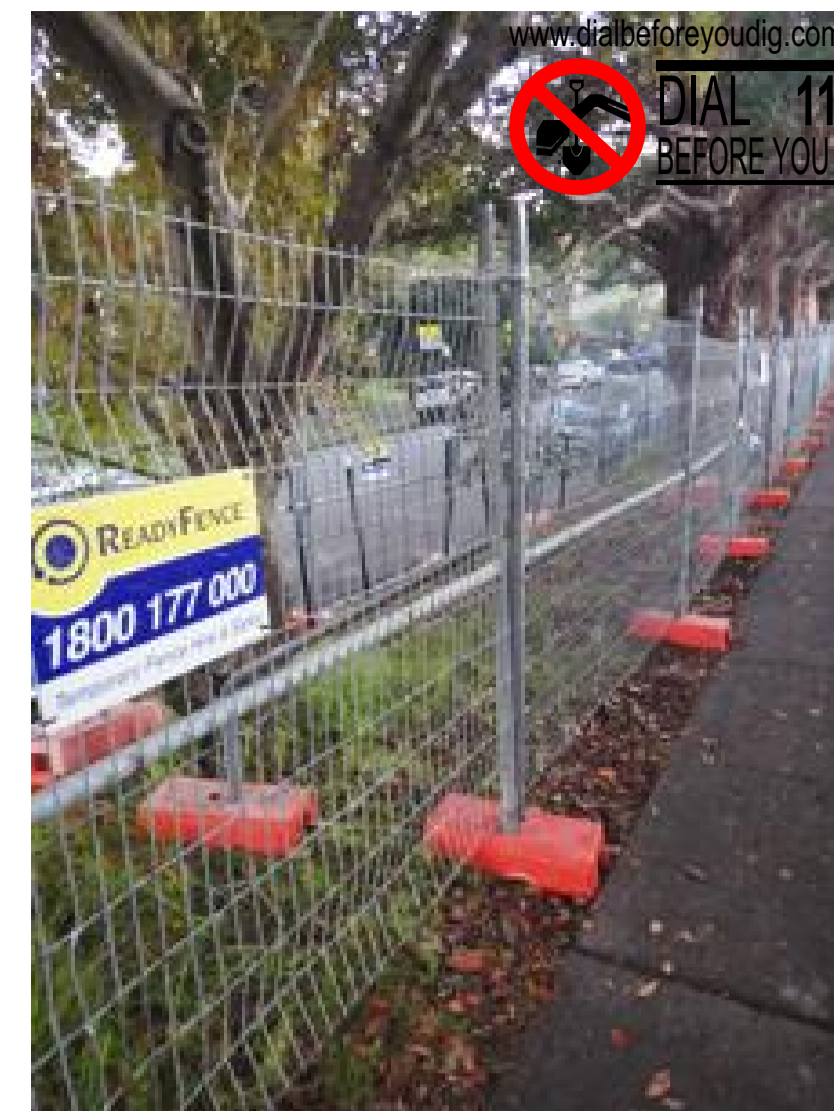
Example image of acceptable tree protection fencing measures to be applied. (1.8m high rigid metal fencing with appropriate lateral bracing)

All tree protection fencing shall be 1800mm high galvanised chain wire or welded steel mesh. Fencing must be bolted together and secured with the necessary back slays and bracing.

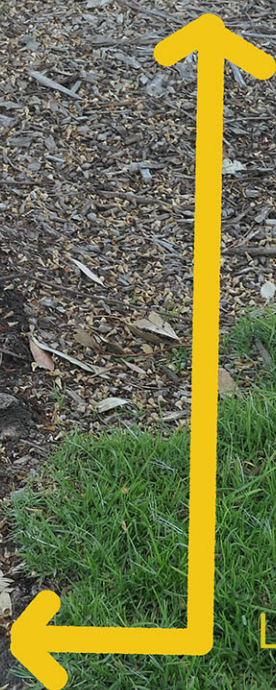
Tree T19

Large surface roots
